JD-87-GP07

CONTRACT NO: DAAK70-87-C-0061

FINAL REPORT

SDMHE DRIVELINE BENCHTEST

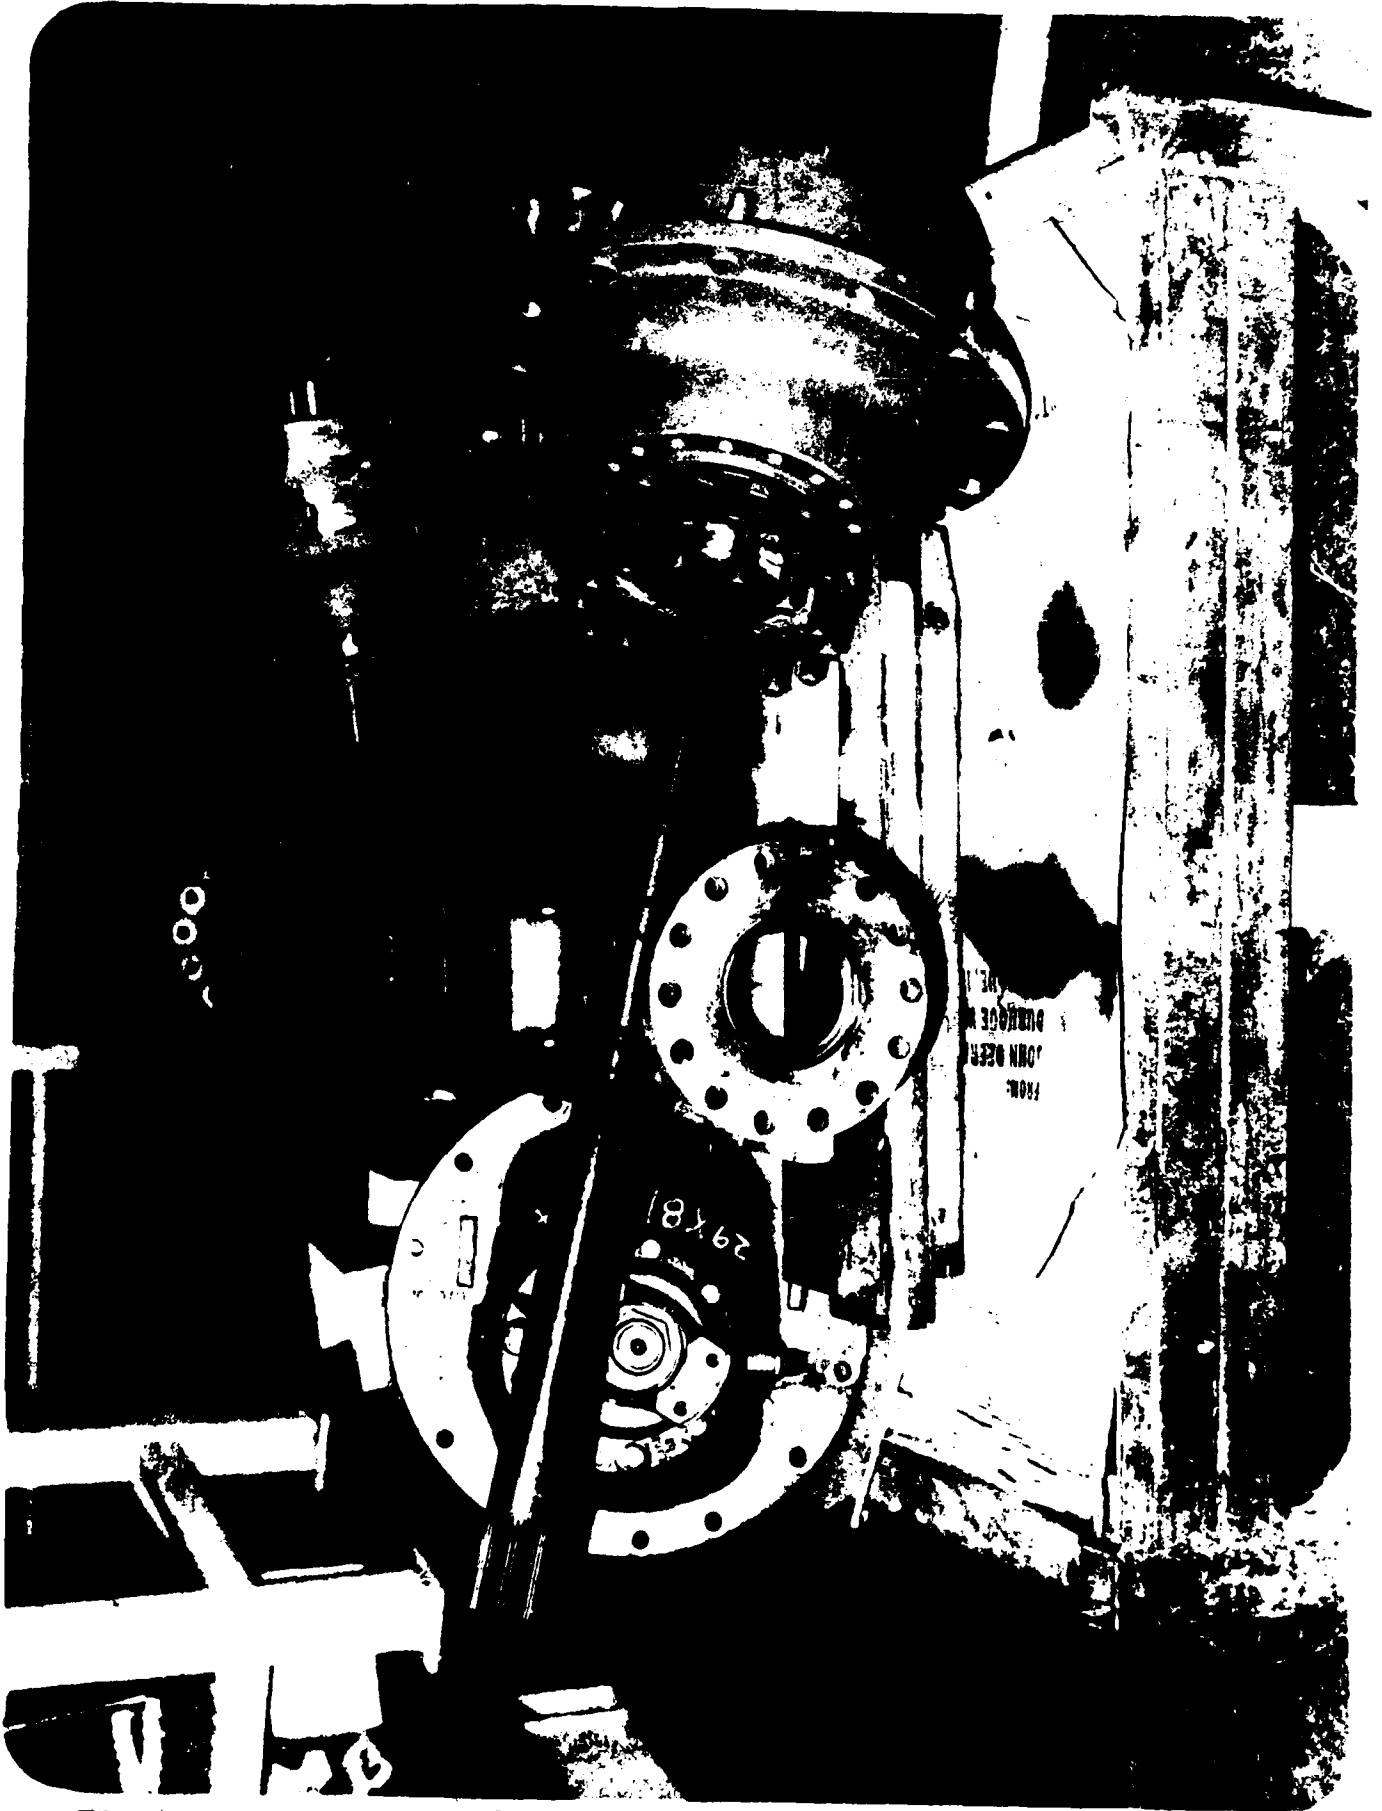
Planetary and Axle Shaft Assembly removed from Axle Assembly

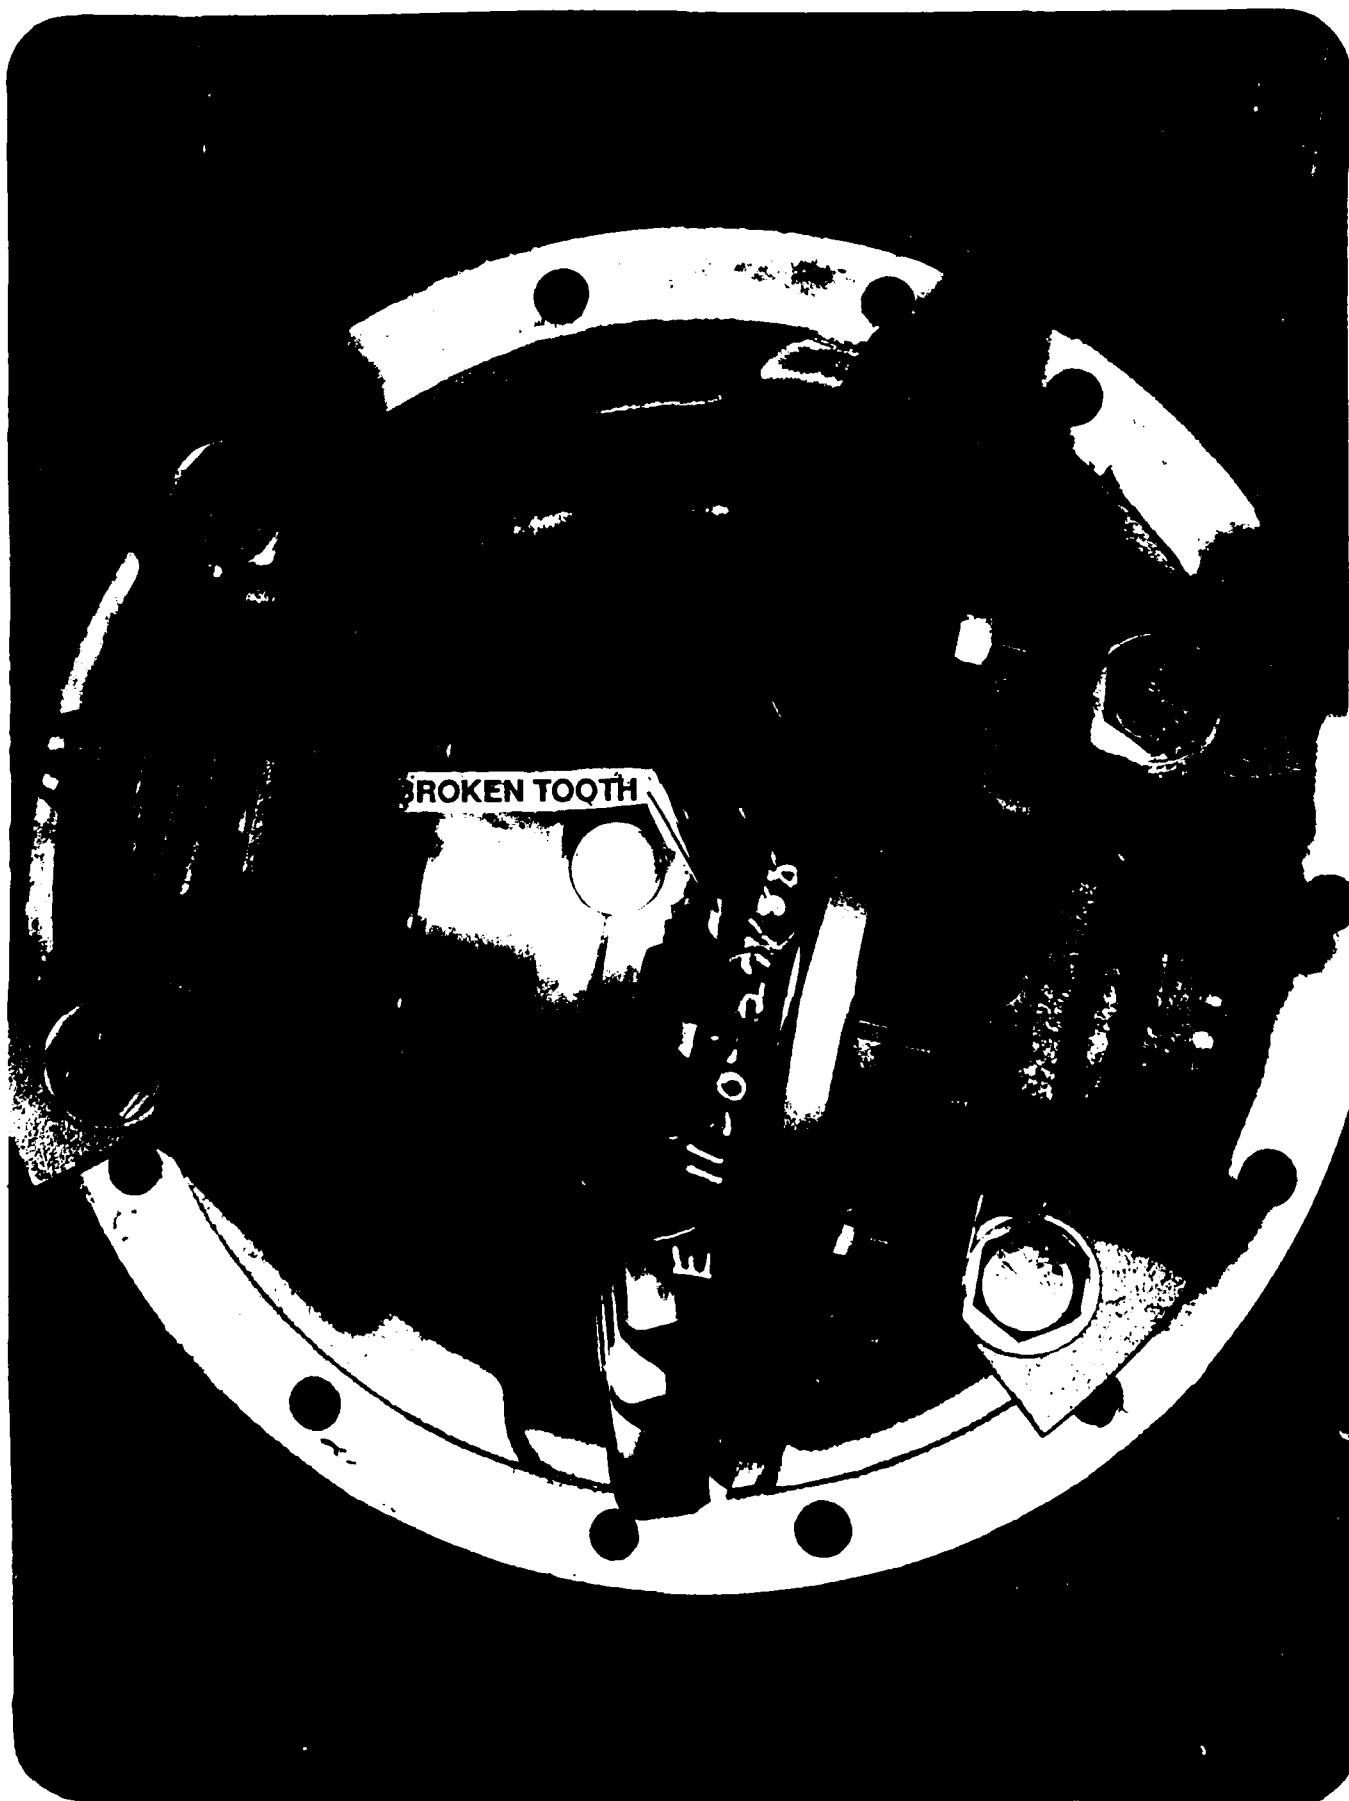
The low speed laboratory test was terminated per telephone agreement of 16 February 1989 with David Krawchuk of the U.S. Army. This termination was the result of the second of two similar failures of the spiral bevel ring gear in the differential of the front axle assembly. Test termination occurred with 865 of the scheduled 1538 low speed laboratory test hours (Activity 14) complete.

Final Spiral Ring Gear Failure

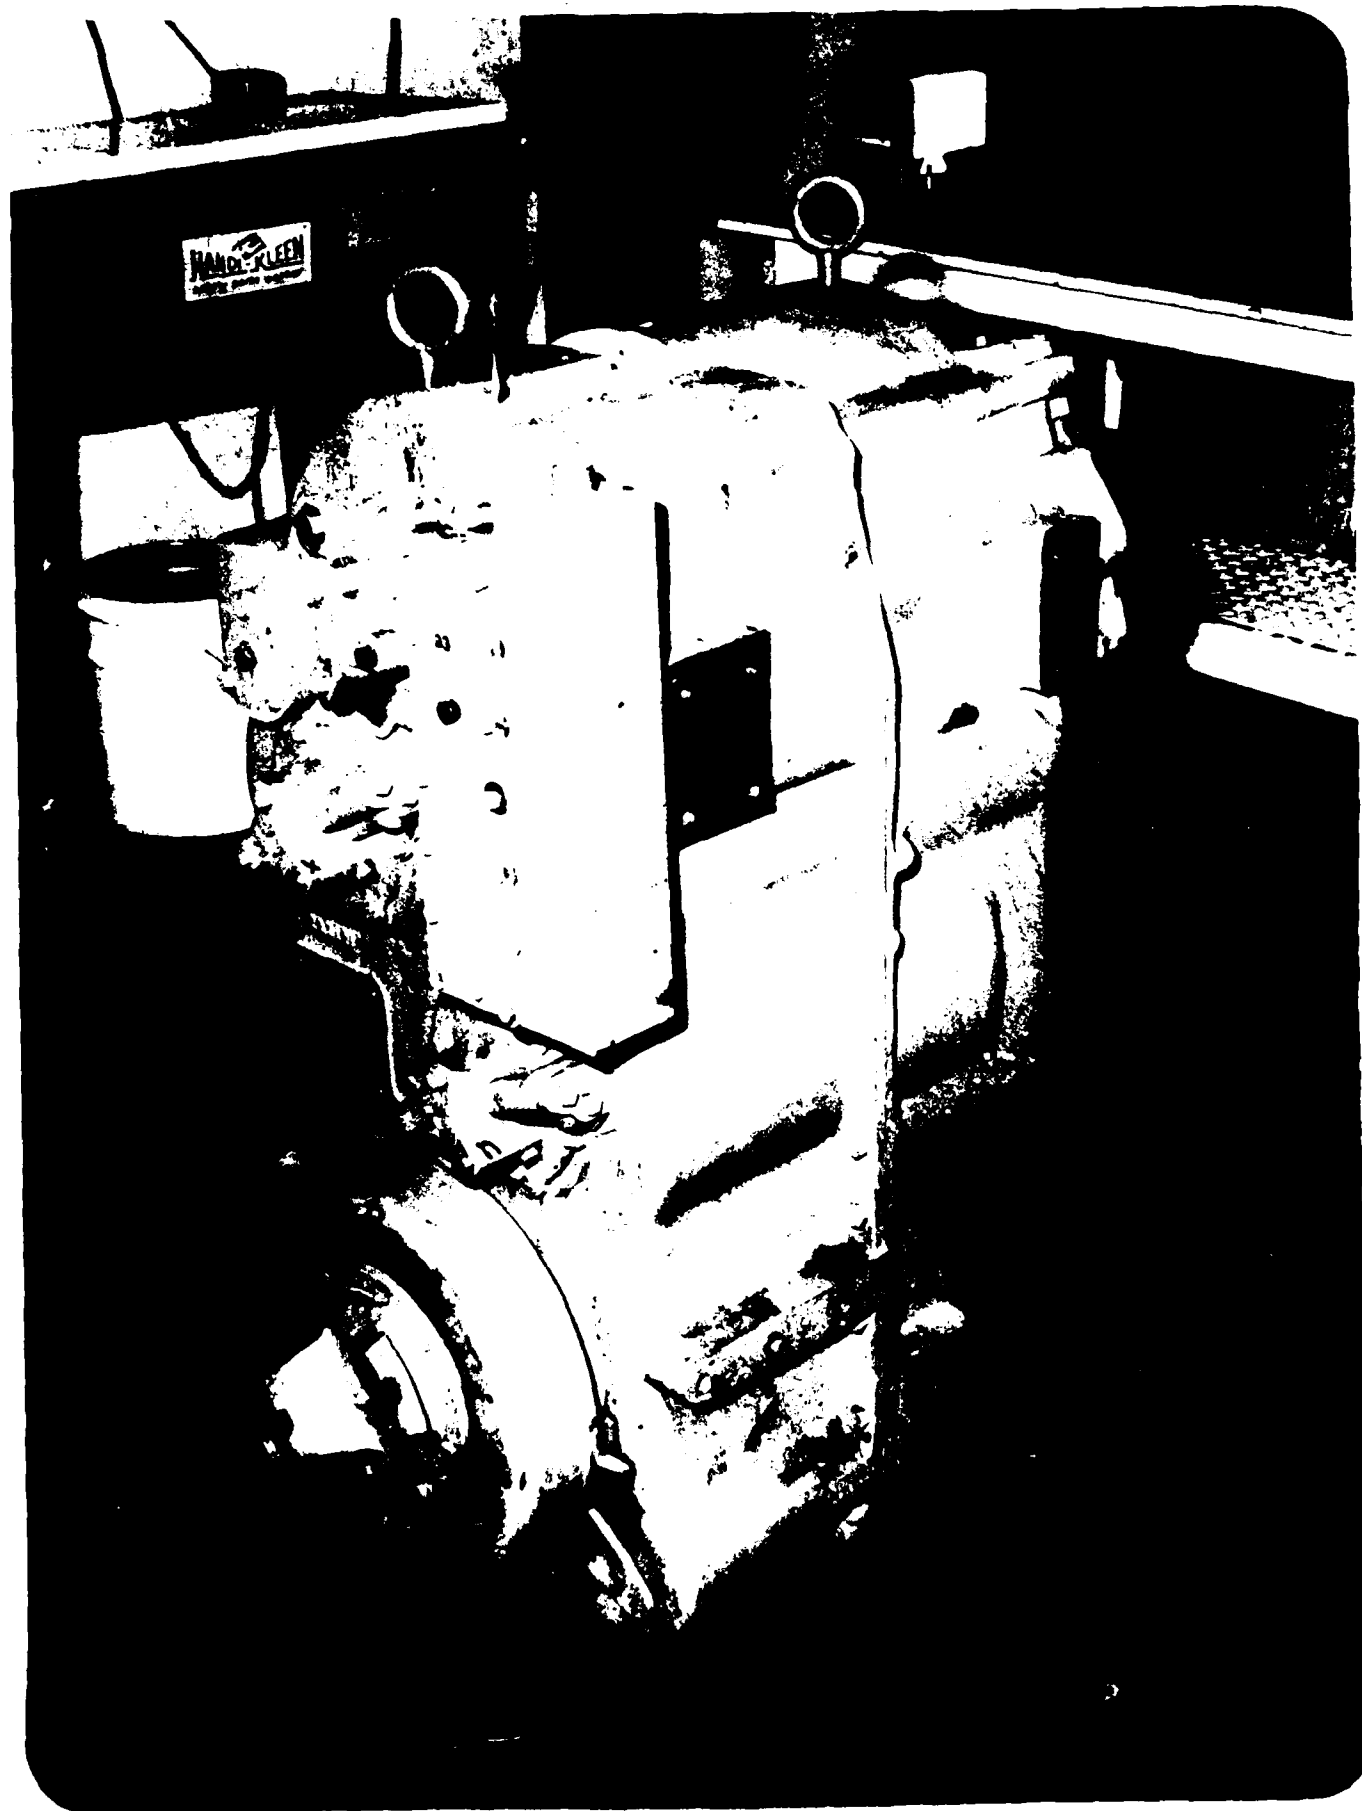
Transmission External View

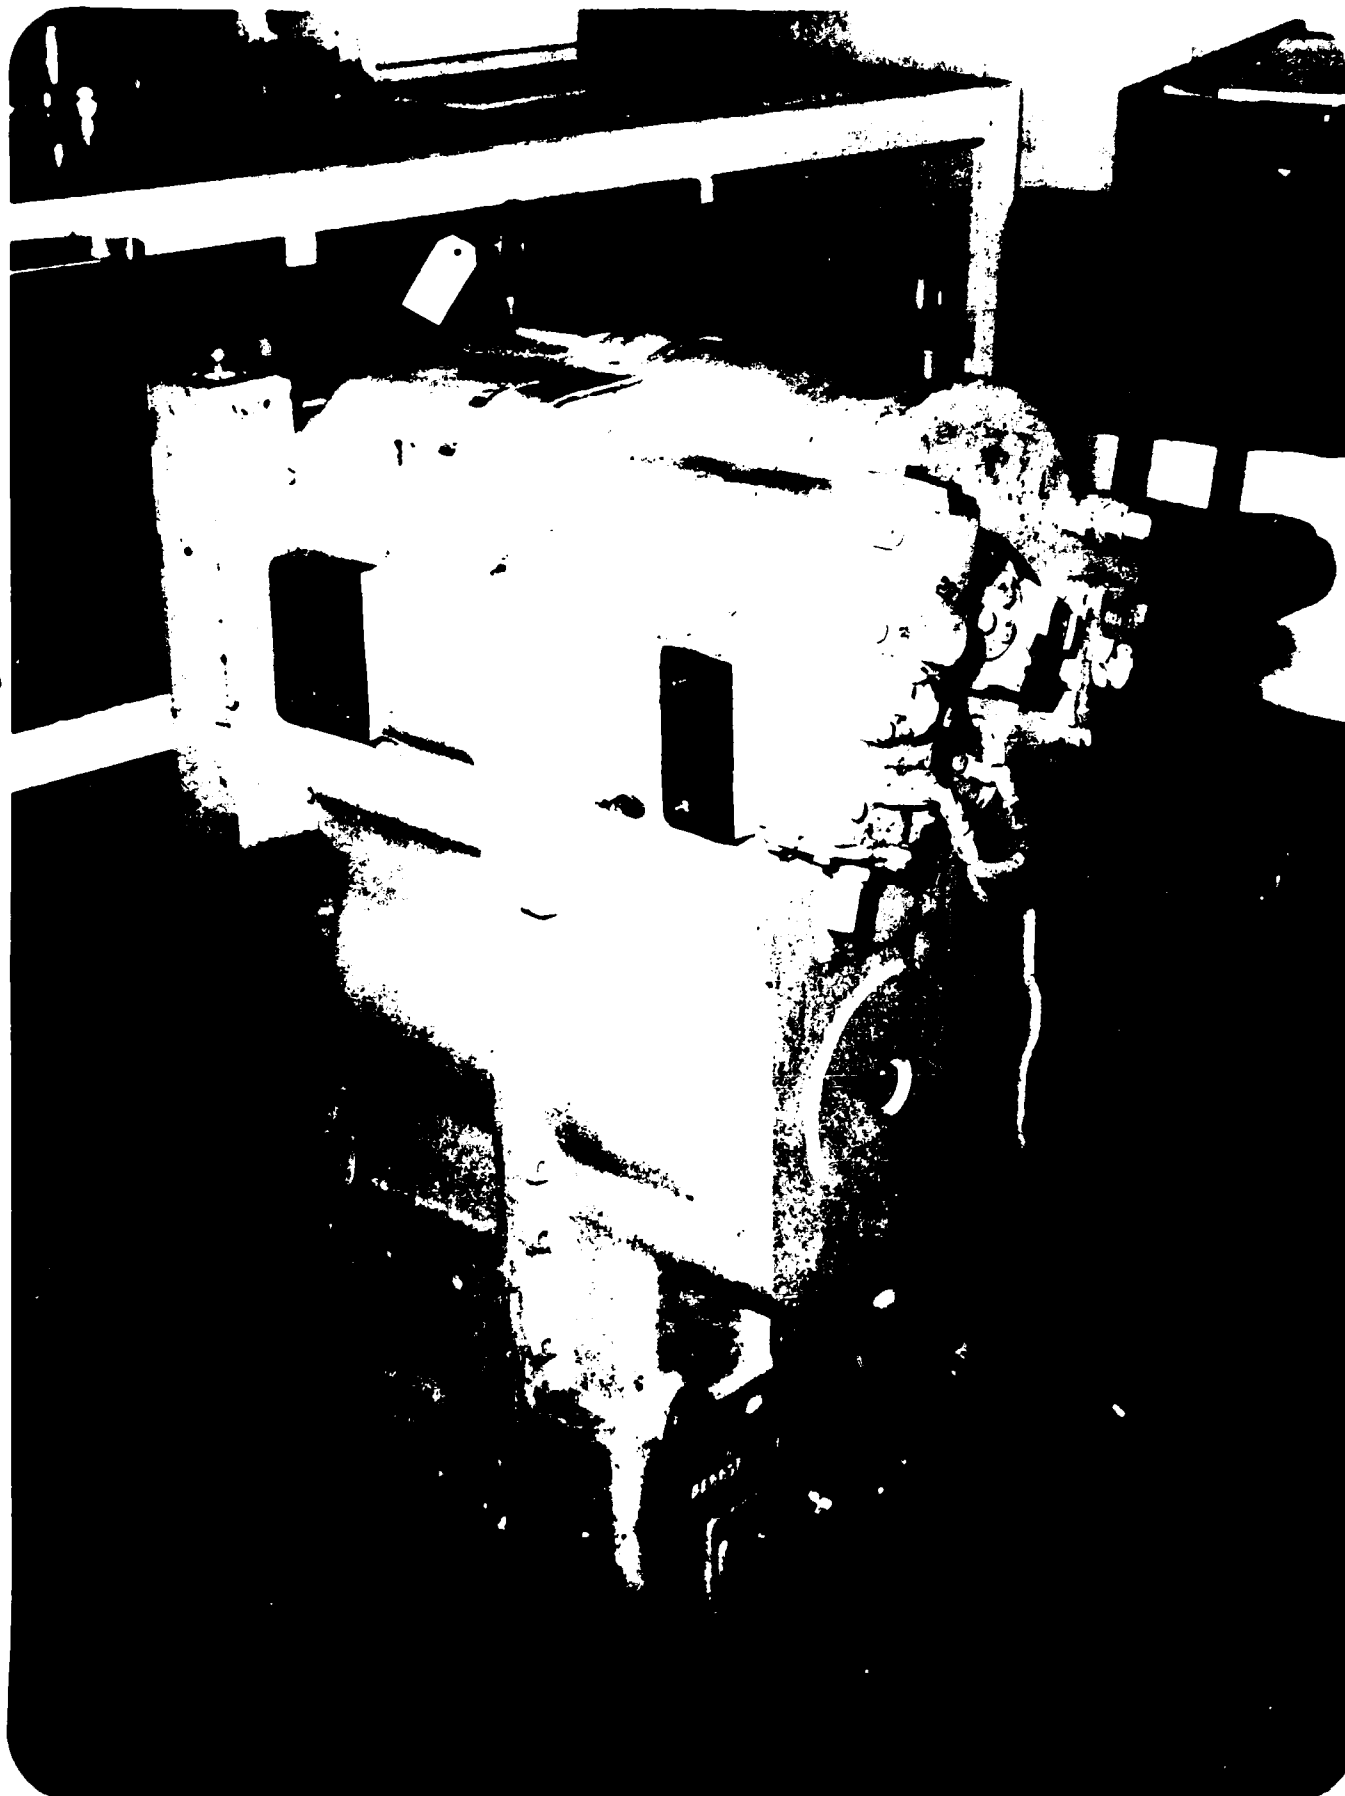
Transmission External View

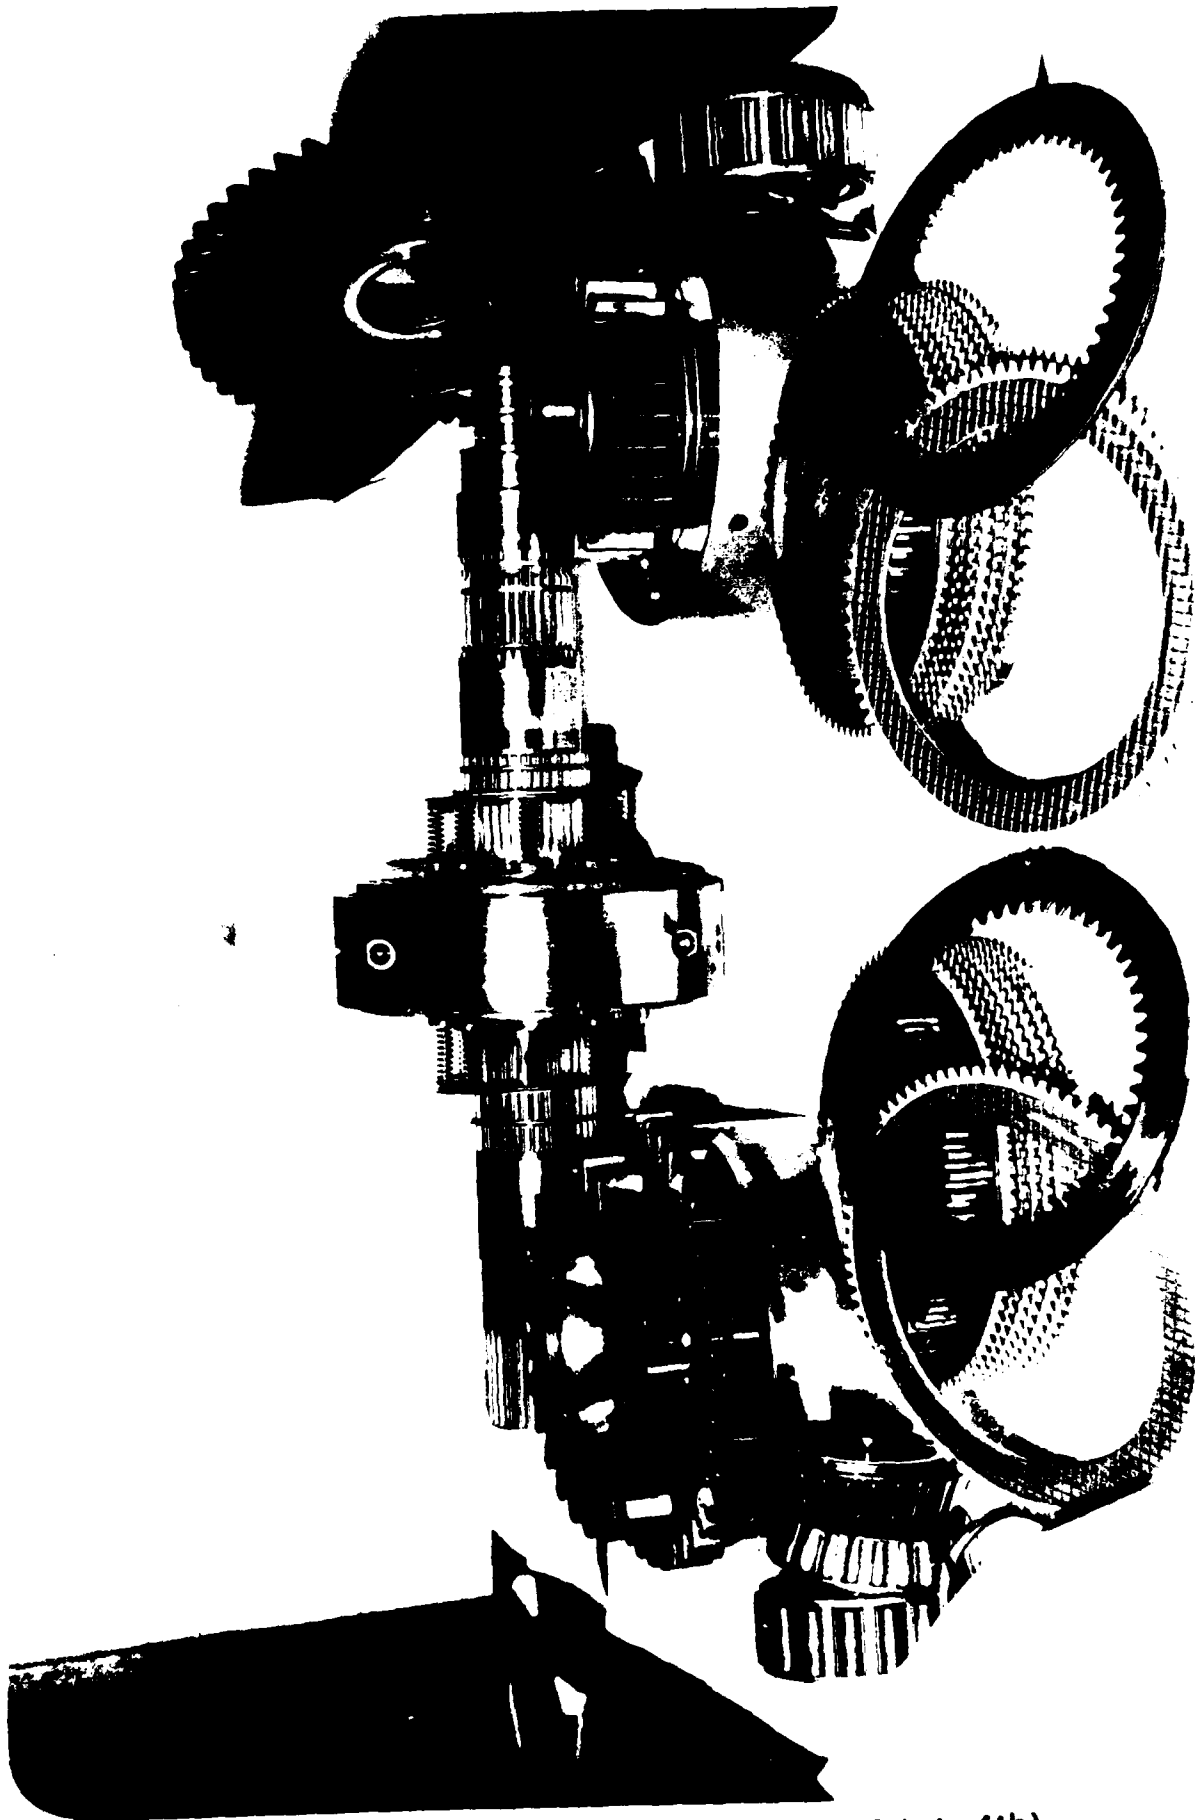
7-Inch Clutch Pack (2nd, 5th & 1st, 4th)

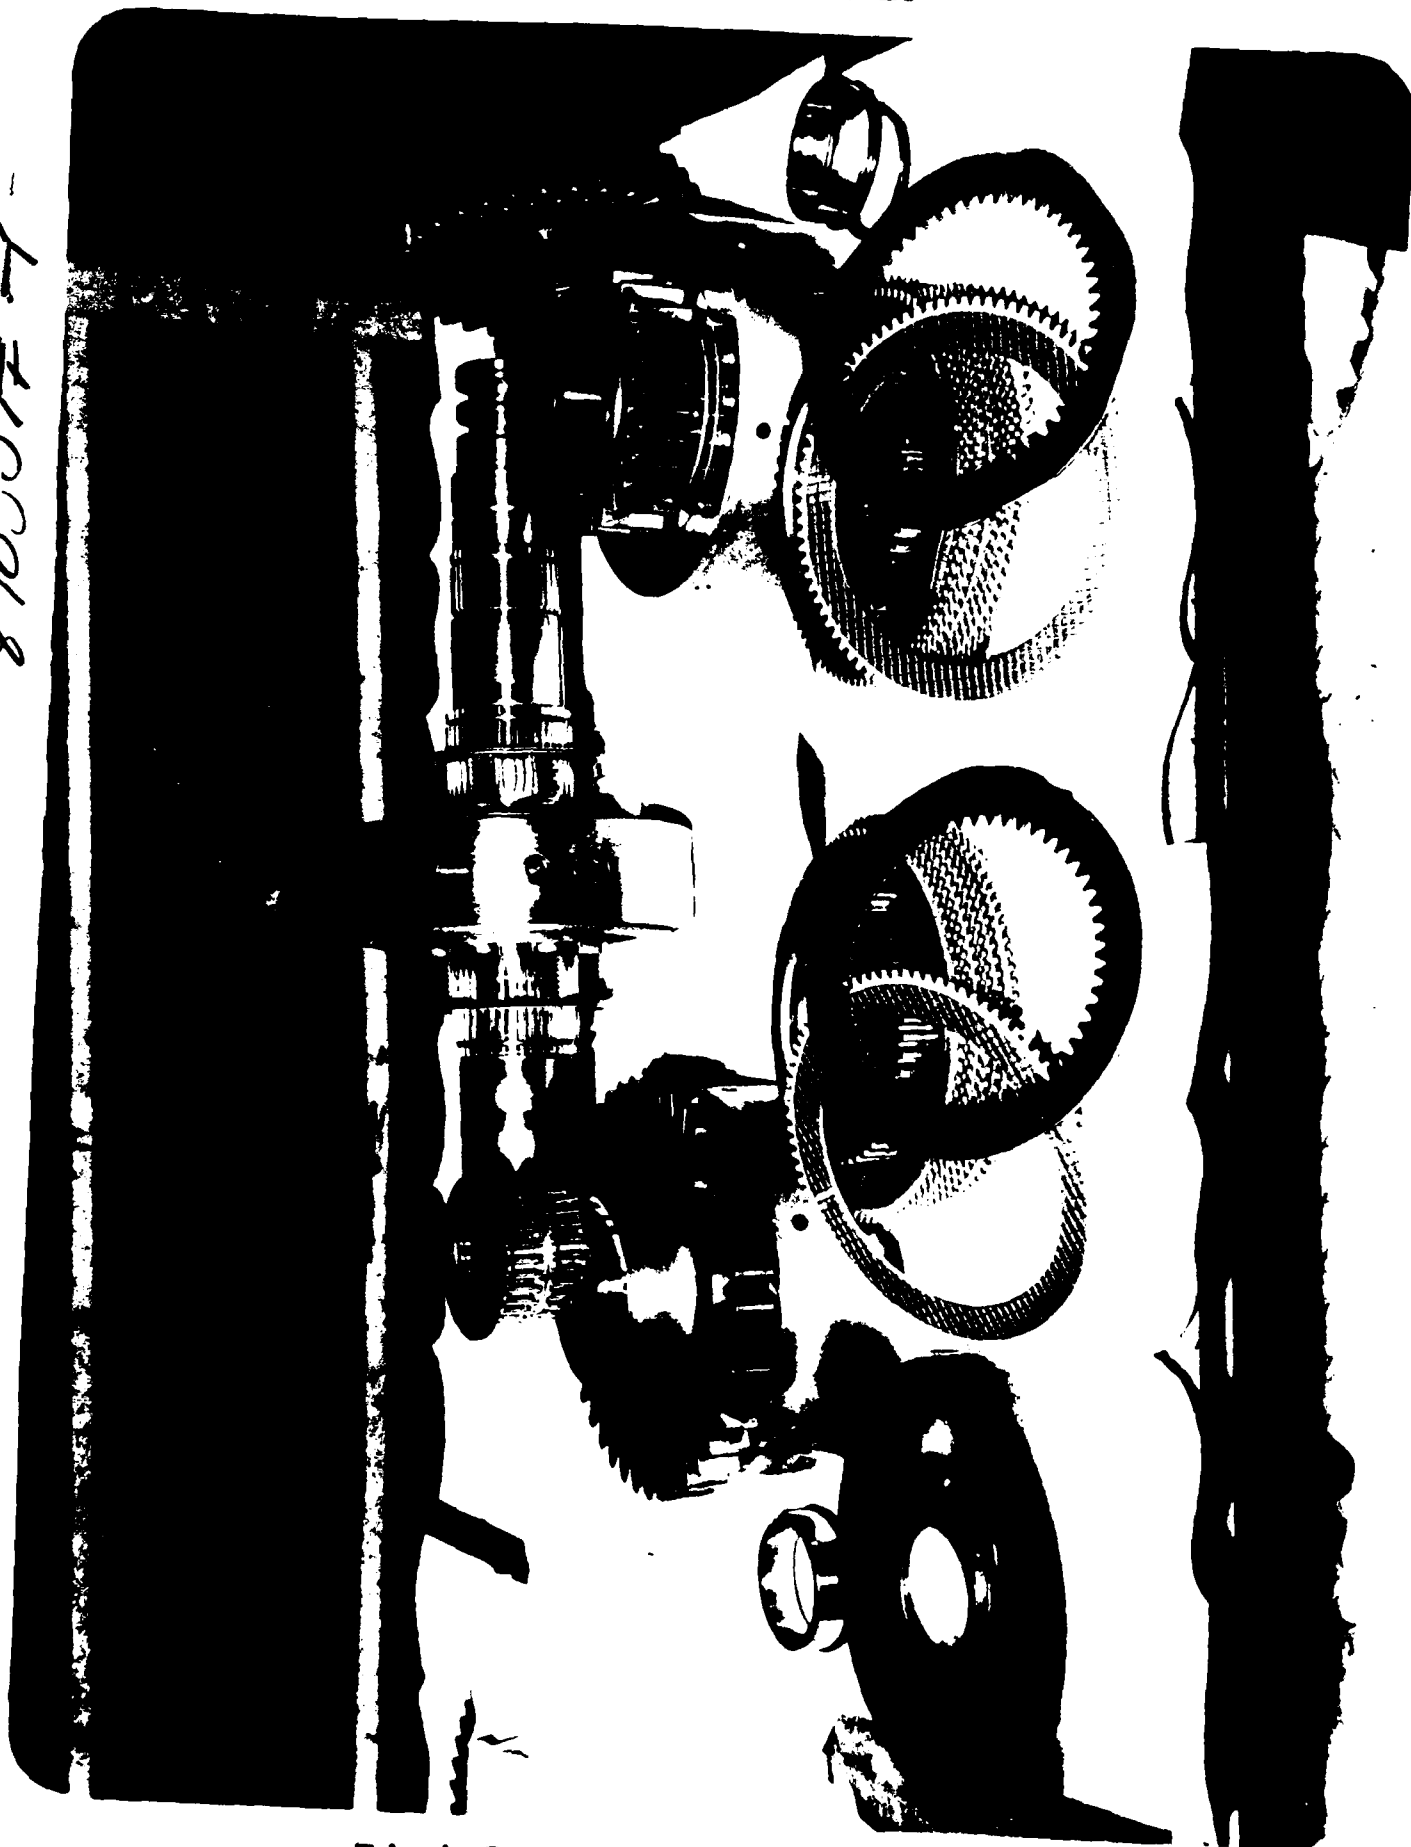
7-Inch Clutch Pack (3rd, 6th & Rev)

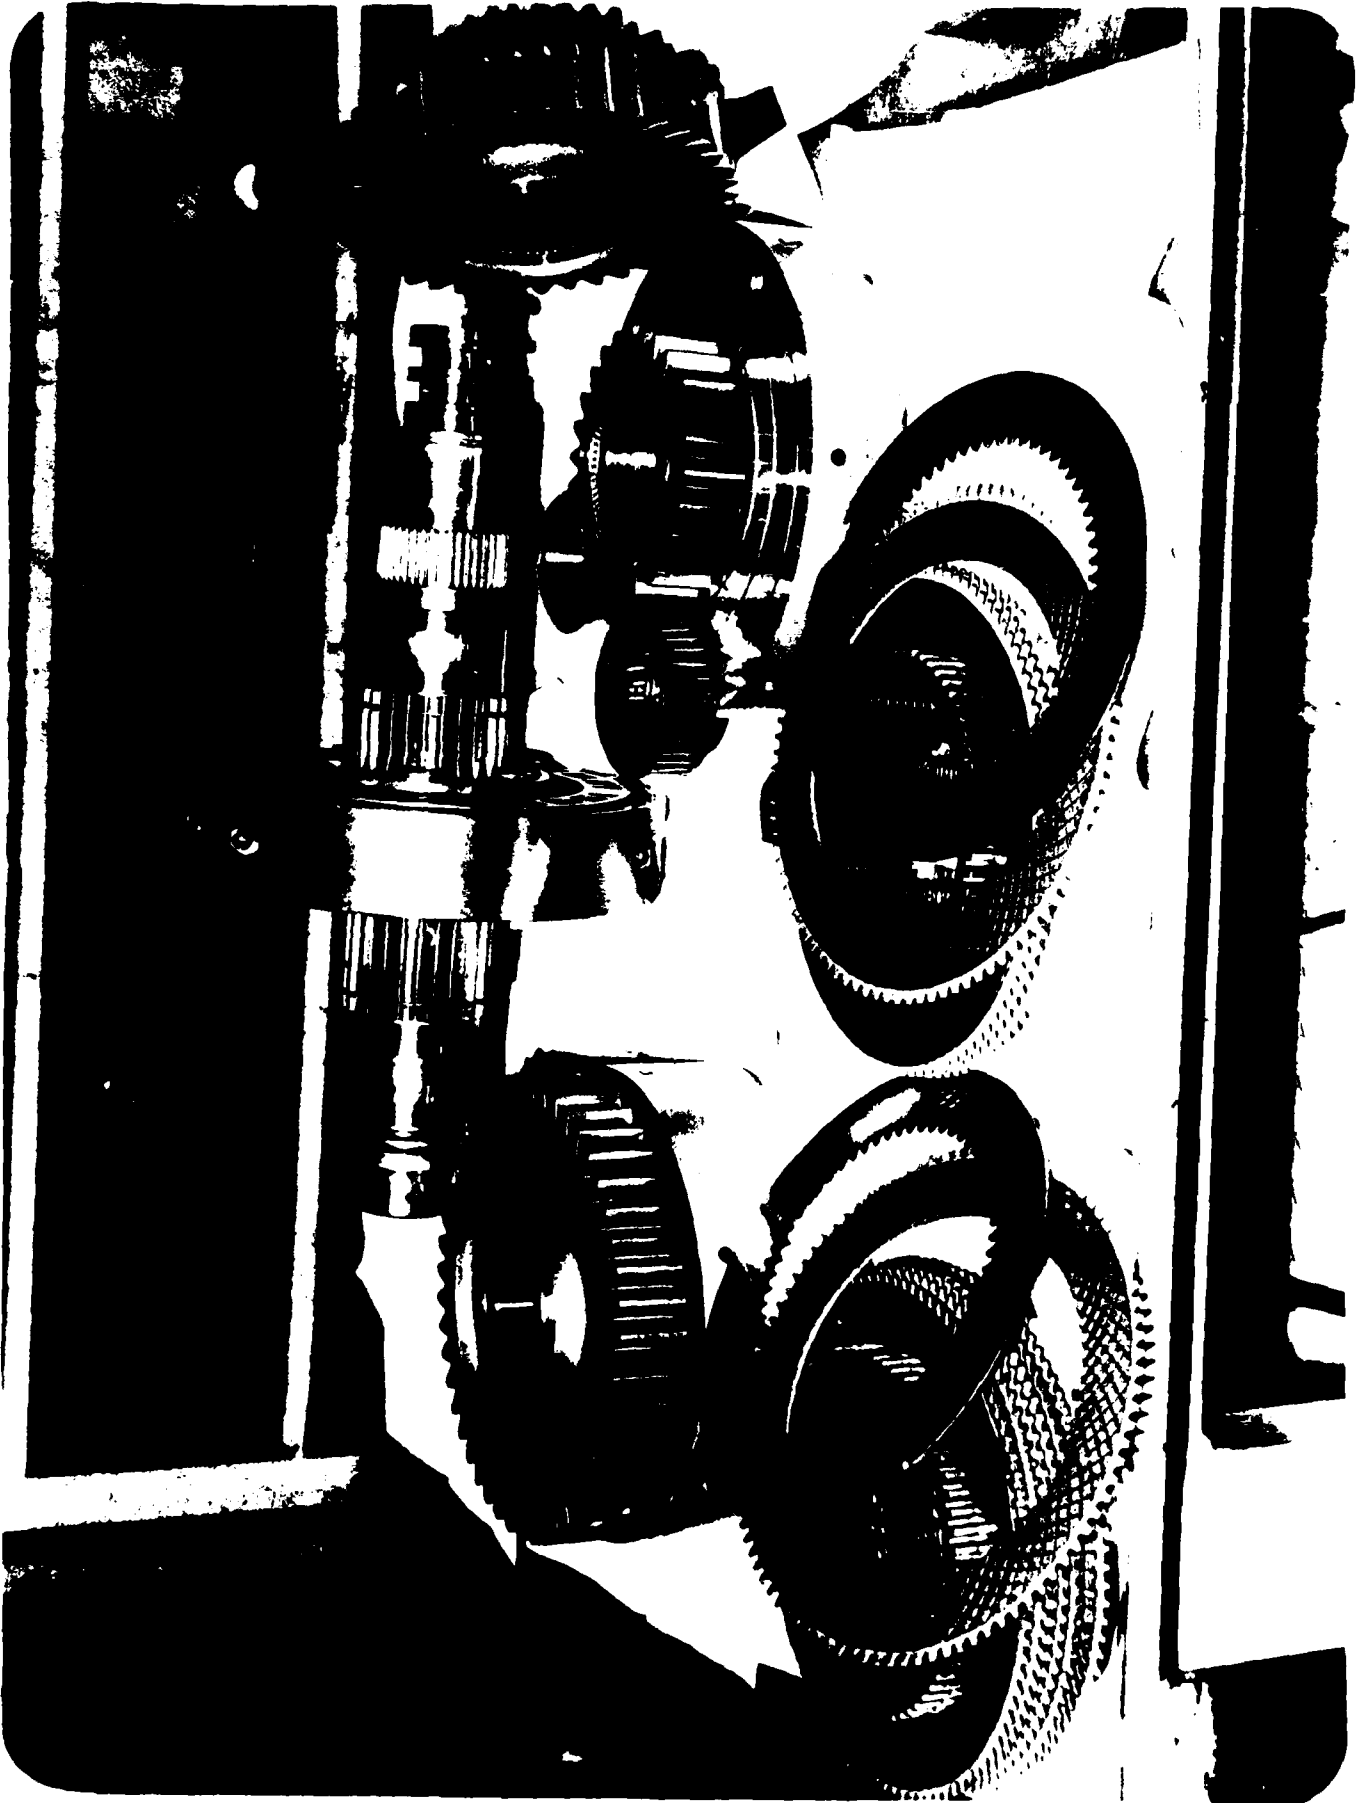
PHOTOGRAPH 30

9-Inch Clutch Pack (Rev, 1st, 2nd, 3rd &, 4th, 5th, 6th)

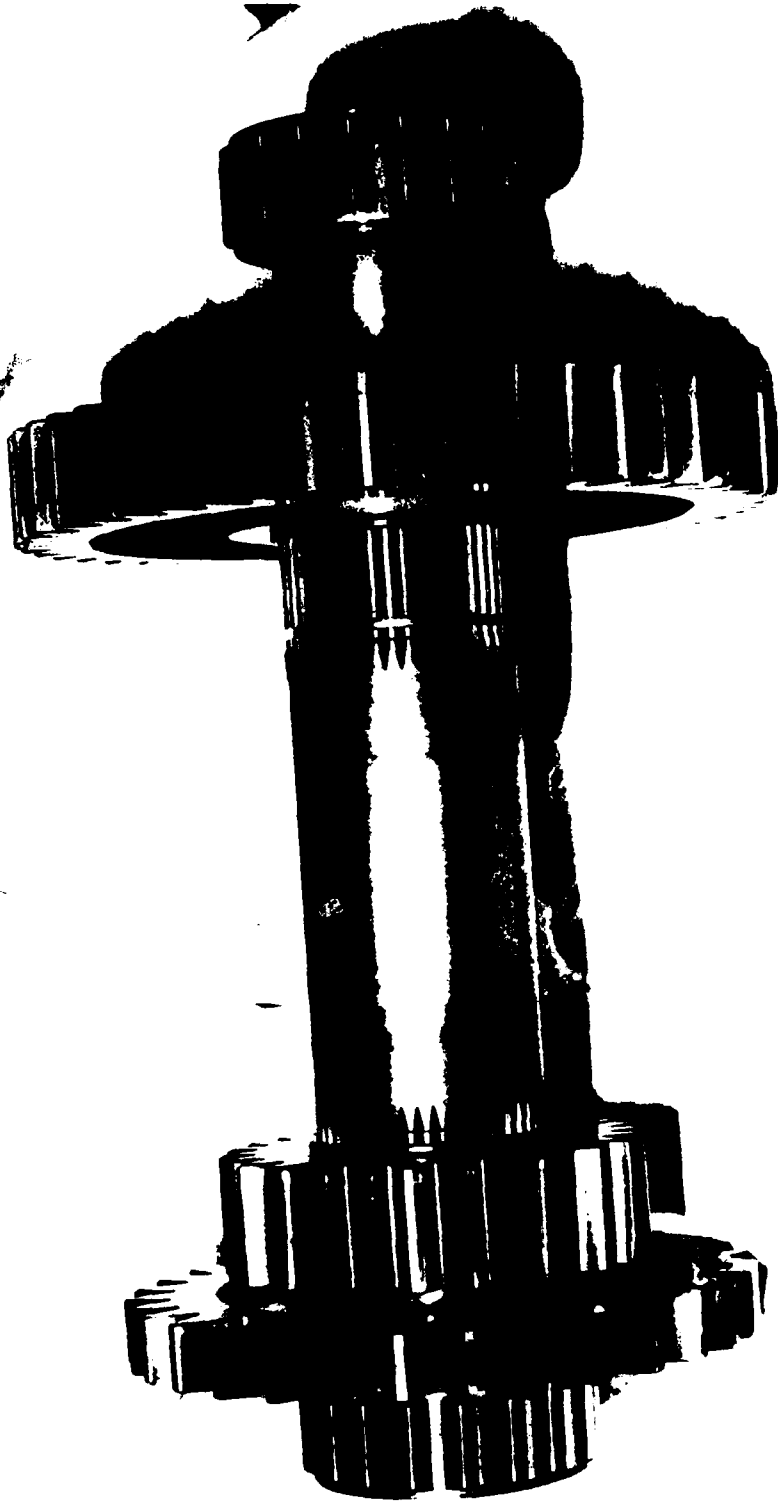
Compound Shaft

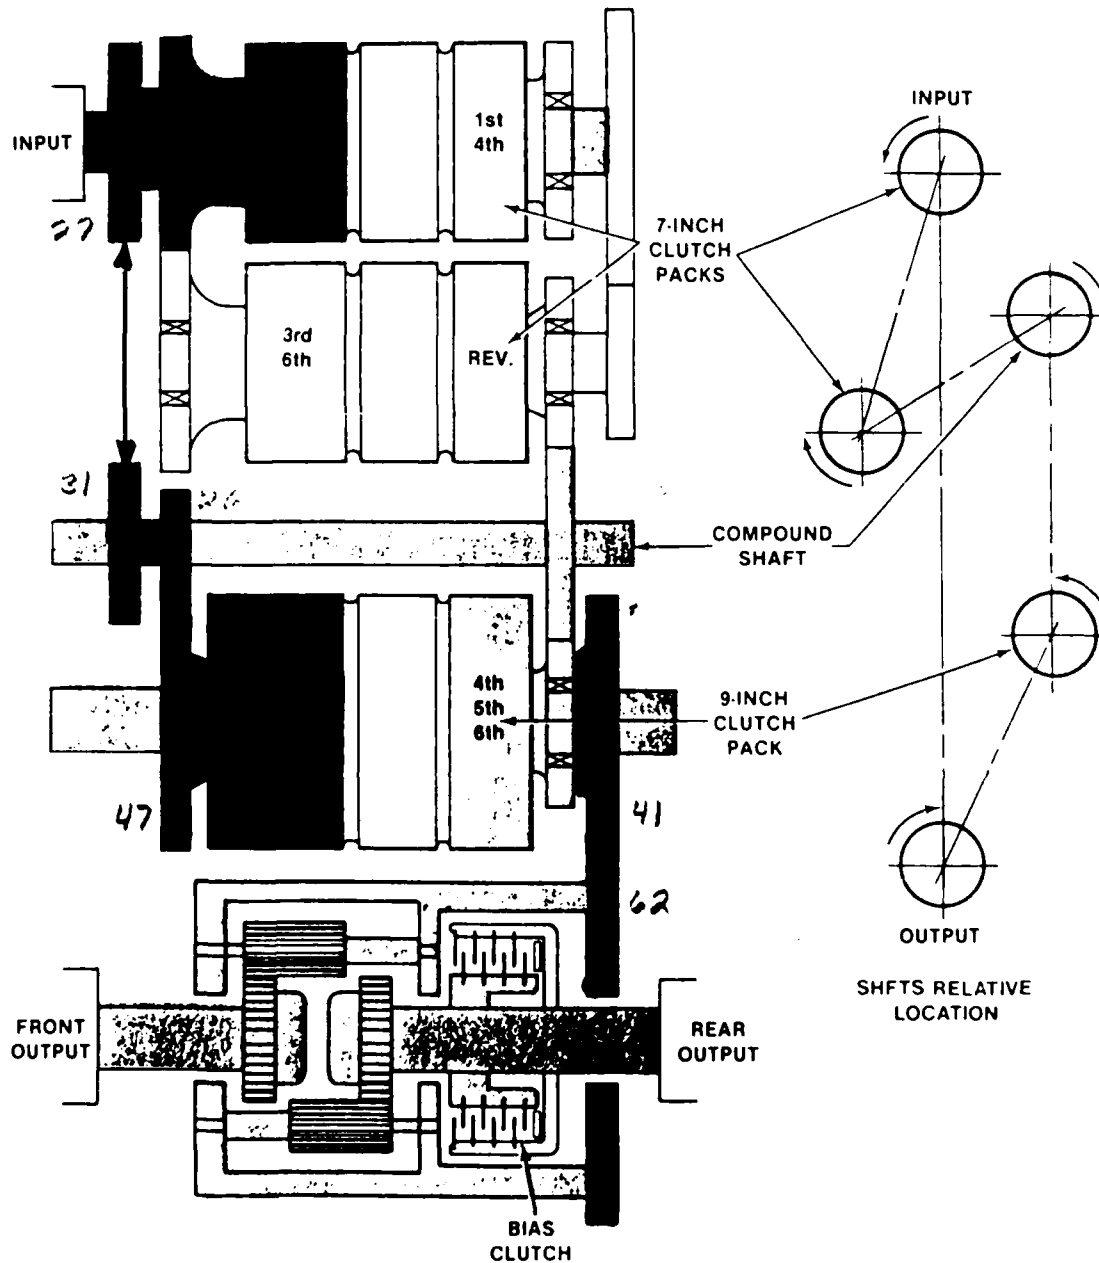
2F

$$\text{TORQUE INCREASE RATIO} = \frac{31}{27} \times \frac{47}{26} \times \frac{62}{41} = 3.138$$

$$\text{SPEED INCREASE RATIO} = \frac{27}{31} \times \frac{26}{47} \times \frac{41}{62} = .318$$

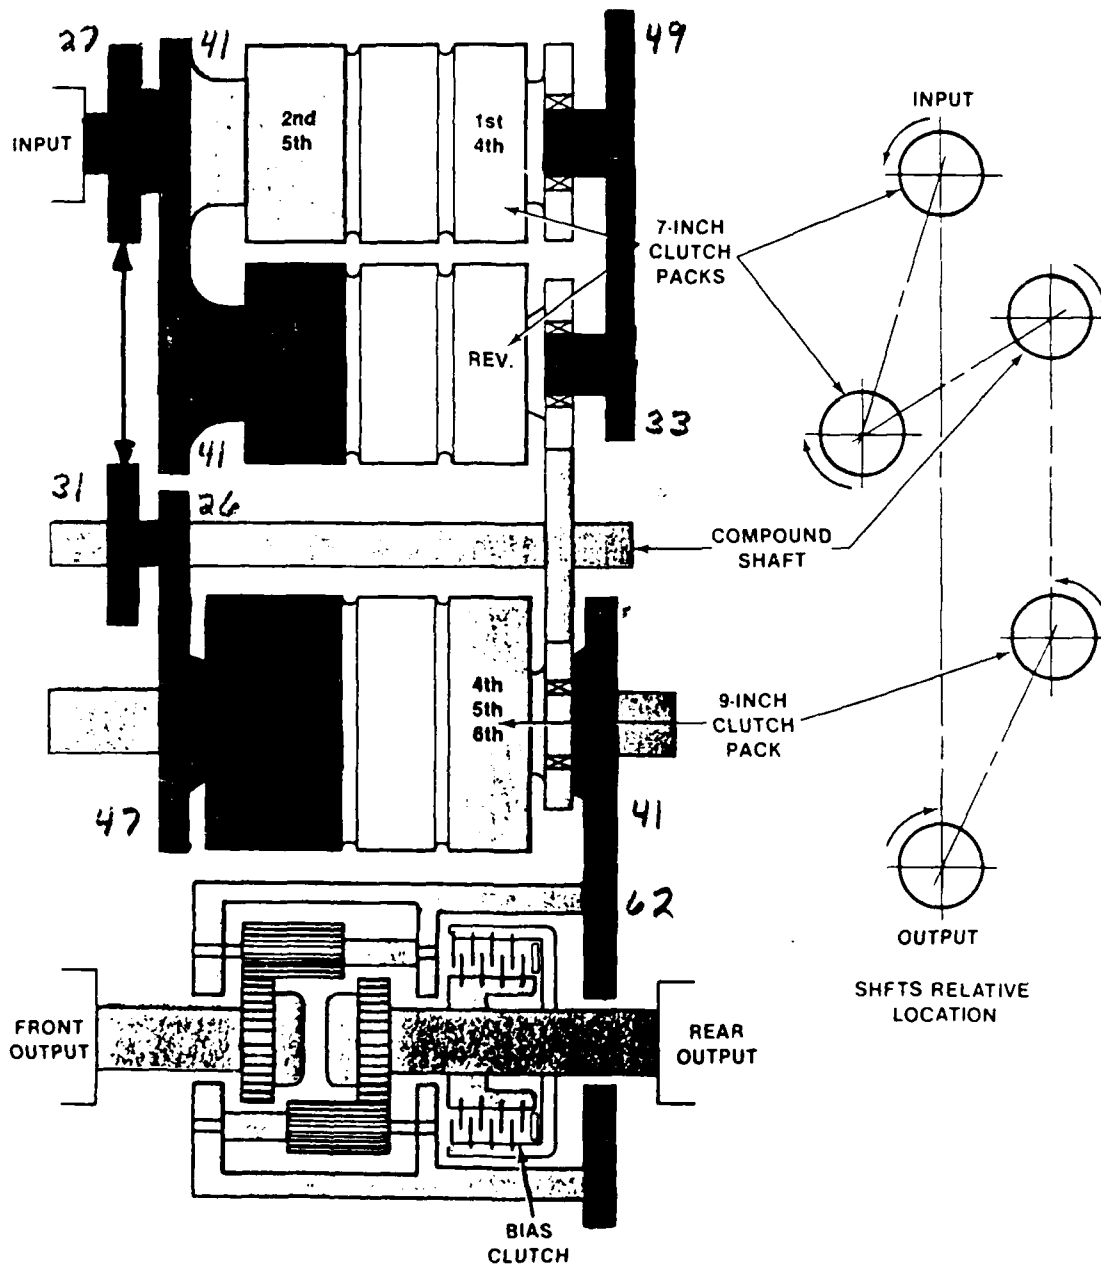
3 F

$$\text{TORQUE INCREASE RATIO} = \frac{33}{49} \times \frac{41}{41} \times \frac{31}{27} \times \frac{47}{26} \times \frac{62}{41} = 2.114$$

$$\text{SPEED INCREASE RATIO} = \frac{49}{33} \times \frac{41}{41} \times \frac{27}{31} \times \frac{26}{47} \times \frac{41}{62} = .473$$

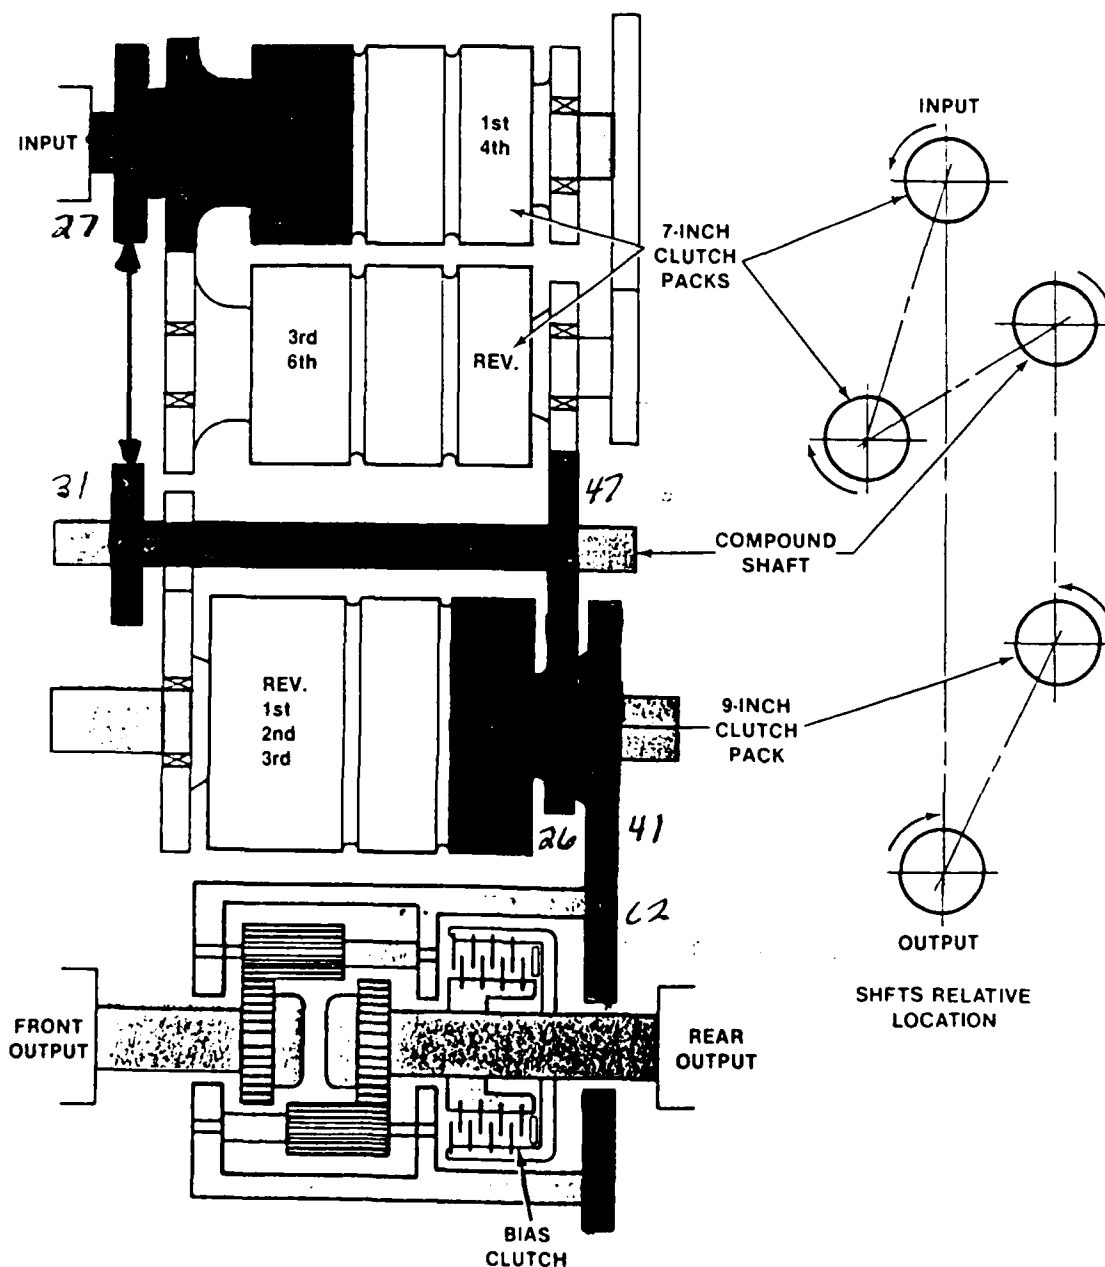
5F

$$\text{TORQUE INCREASE RATIO} = \frac{31}{27} \times \frac{26}{47} \times \frac{62}{41} = .961$$

$$\text{SPEED INCREASE RATIO} = \frac{27}{31} \times \frac{47}{26} \times \frac{41}{62} = 1.041$$
